Impact Damage Resistance of Carbon/Epoxy Composite Tubes for the DC-XA Liquid Hydrogen Feedline

NASA Technical Paper 3583

Marshall Space Flight Center • MSFC, Alabama

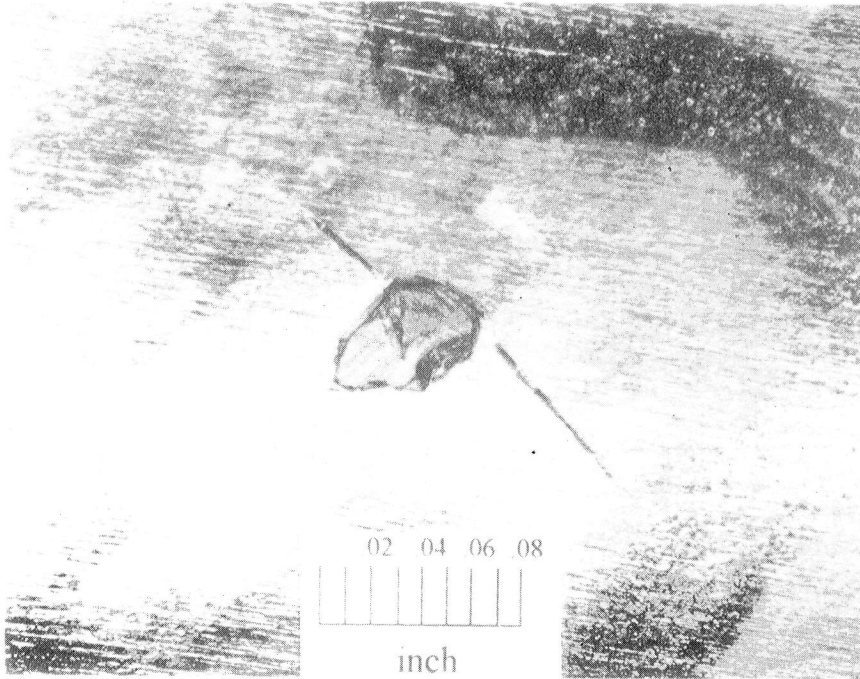
Hit No. 7

On impact No. 7, the first hit that did not produce obvious external damage, the photomicrograph shows that a small crater has formed in the outer gel coat of the tube's surface. Two small cracks in the gel coat propagate from this crater. Specimen dissection, discussed in the next section, will show if any fiber damage has occurred. However, no fiber damage needs to occur for permeability to be present, only a leak path through the matrix resin is needed.

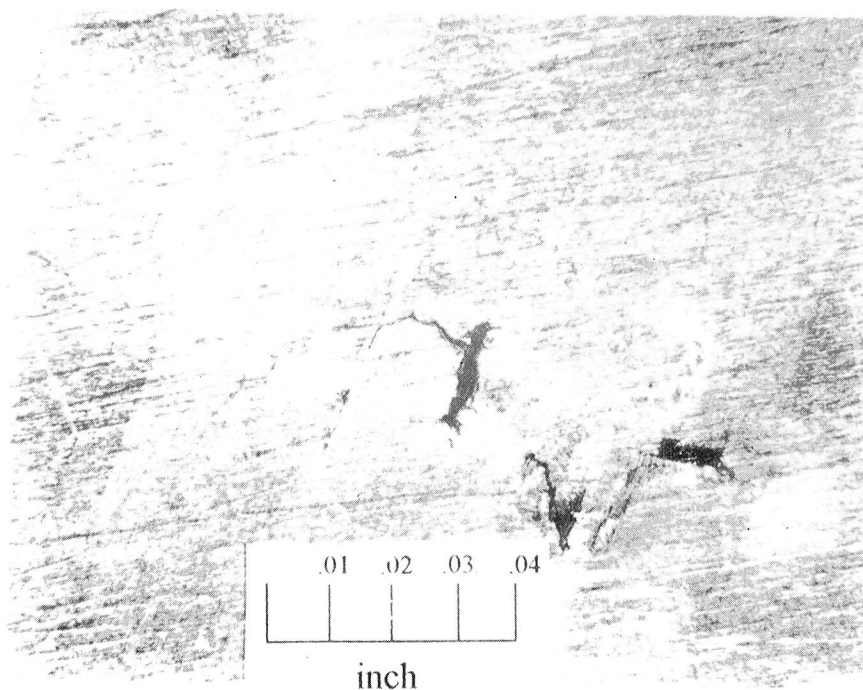
Hit No. 8 is an example of damage that did not cause detectable leakage, yet was visible under microscopic examination. While damage such as this may not cause detectable leakage of argon gas using a soap based leak detector solution, hydrogen permeation may still occur at high rates.

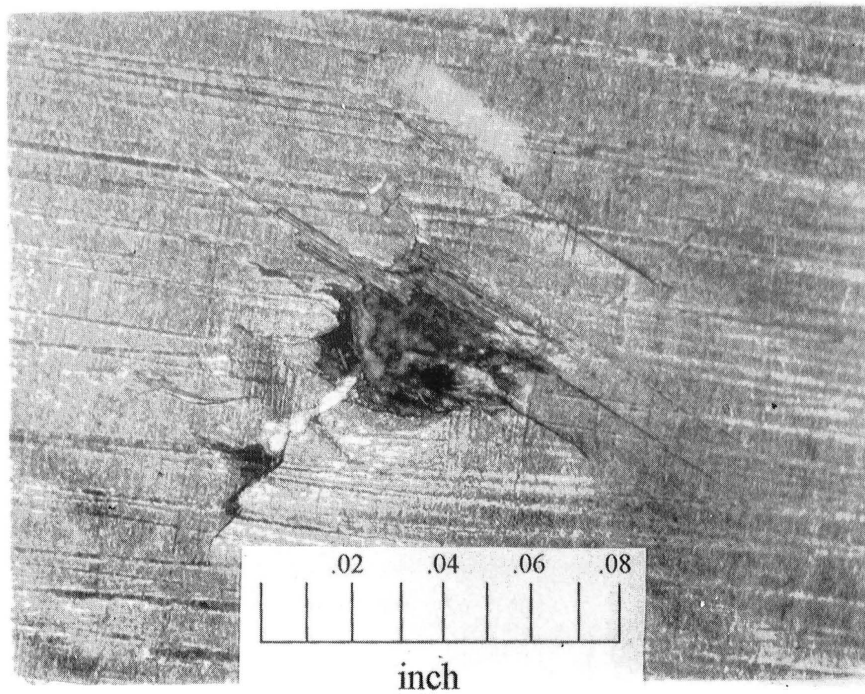
Hit No. 10

Also of interest is hit No. 10 that caused a visible nick in the surface, yet did not cause a detectable leak. The cross-sectional examination results, given in the next section, will show why this is. Hit No. 11 shows far less surface damage than hit No. 10, yet hit No. 11 leaked while hit No. 10 did not. Thus, surface damage alone is not a good indicator of whether or not an impact event will cause leakage. One explanation for this is that hit No. 11 was performed with a 2-mm diameter striker which was relatively blunt compared to the sharpened bolt strikers. The impact energy due to a blunt hit is distributed over a wider area and less contact stresses occur, thus the energy is dissipated as matrix cracking through the entire thickness of the tubes instead of the localized puncture that may not go through the thickness. This seems to be the case since all impacts with the 2-mm diameter striker caused leaks even though the impact energies were lowered to the lowest level used with the sharpened bolts (~0.8 J).

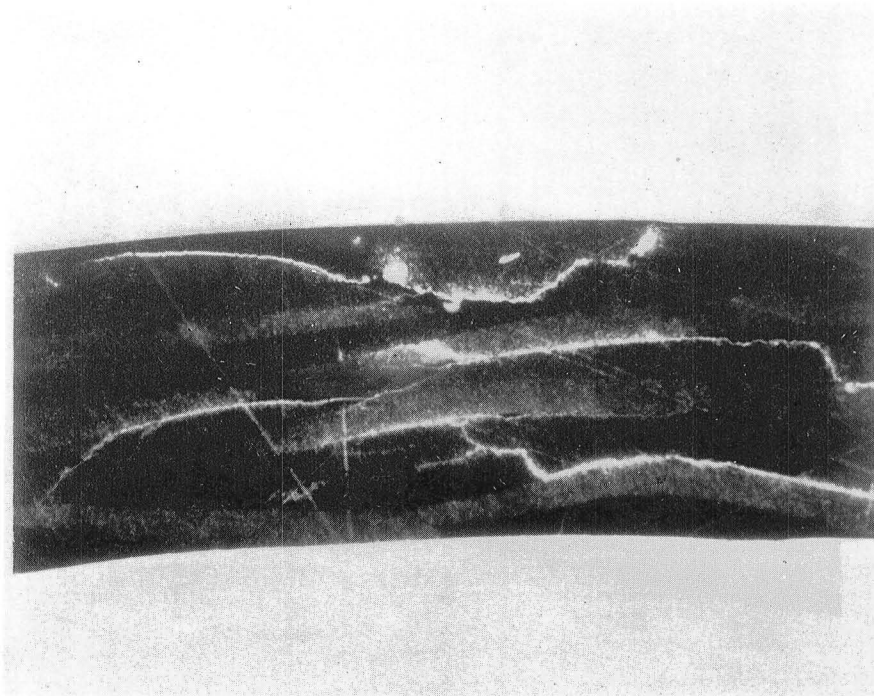
Hit No. 7

From the cross section of hit No. 7, it can be seen that no fiber breakage is present, but extensive matrix cracking exists. This was found to be typical of all of the impacts except Nos. 1, 2, and 3, which demonstrated obvious fiber breakage visible from the surface. The majority of the lengths of these cracks run between plies of carbon/epoxy as is typical of impact delamination damage. The leak paths form when these lines of delamination are joined by transverse cracks that bridge between layers. Some of these cracks can be seen on the photomicrograph of hit No. 7. Since the entire volume of impact damage cannot be represented by a cross-sectional photograph, a complete leak path may not be visible on any one plane perpendicular to the specimen. Thus, the density of cracks on the plane in the photomicrograph must be used to assess the likelihood of a leak path forming through the entire tube wall thickness. For example, the cross-sectional photograph of hit

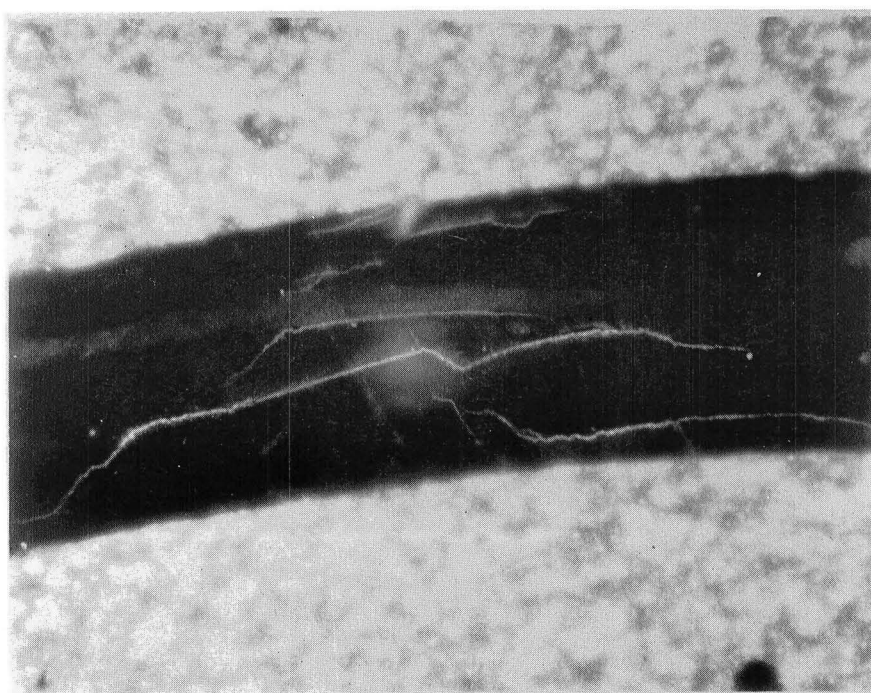
Hit No. 8

No. 8 seems quite similar to that of hit No. 7, yet No. 7 leaked while No. 8 did not. These two photographs represent the borderline impact level at which leakage begins to occur.

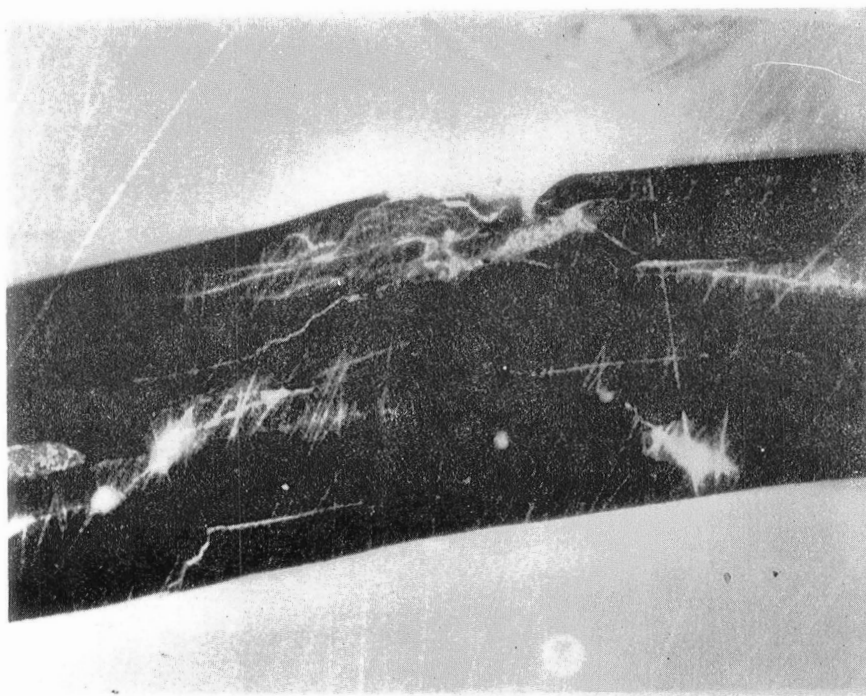
Hit No. 9

The surface damage can be seen in the cross-sectional photograph of hit No. 9. The typical conical region of damage observed in impact damaged composites can be seen in this, and most other, photomicrographs. This type of damage consists of heavy matrix damage below the impact site, with delaminations spreading out further away from this point as the specimen gets deeper.

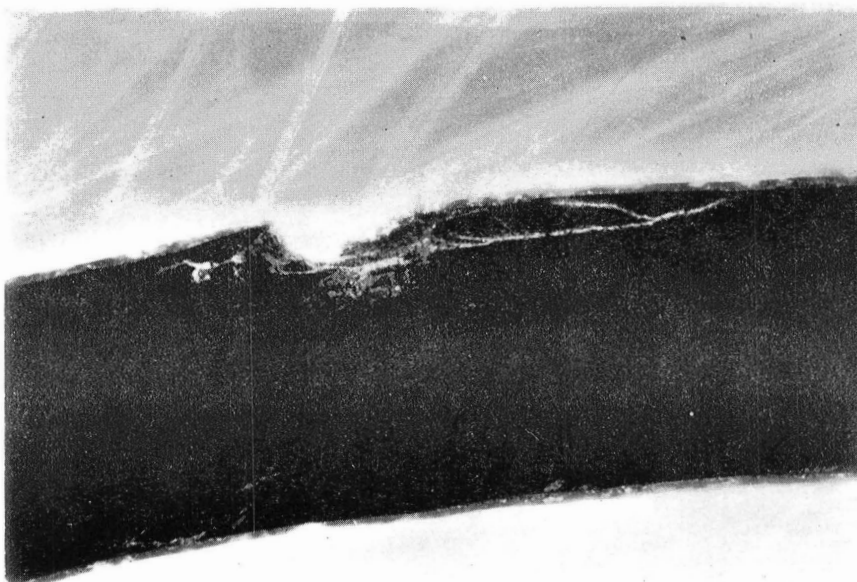
Hit No. 10

As mentioned in the previous section, hit No. 10 sustained a visible surface nick yet did not leak. The photomicrograph of this specimen helps confirm the theory that the punctured area near the surface absorbed most of the incident impact energy, leaving little energy to form delaminations and matrix cracking deeper in the specimen. The photomicrograph of hit No. 11, which was similar to hit No. 10 only with a more blunt striker, shows that not as much surface damage was inflicted upon the specimen, allowing the impact energy to be dissipated into the entire thickness of the tube wall as delaminations and matrix cracking.

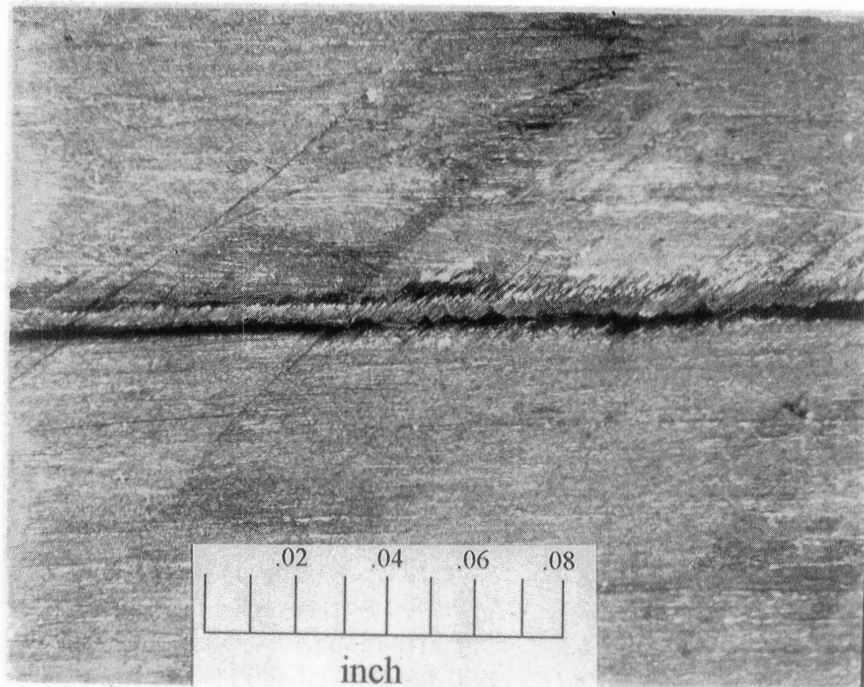
Hit No. 4

to spread the impact energy over a larger area, reducing localized damage. Note that on hits No. 4 and 6, the cracking was contained within the seam of the gel coat caused by the outer clamshell mold used in the processing of the part. These areas are resin rich, and the cracks can propagate much more easily in these areas than in those outside the seam which contain fibers closer to the surface. This indicates that impacts that occur on the "seam" of the tube may be much more difficult to visually inspect, thus care must be taken for these impacts.
